Overview of Riparian Restoration in the Southwest

David R. Dreesen, Ph.D. – USDA-NRCS New Mexico Plant Materials Center

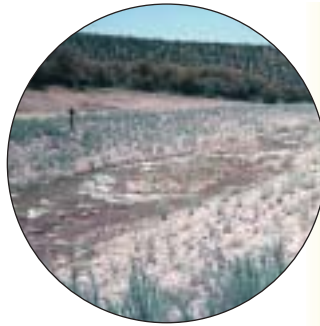
Channelized stream without riparian vegetation. (Photo: Apache-Sitgreaves National Forests)

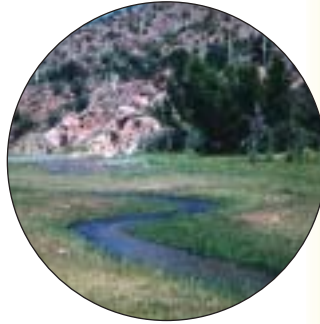
Revegetated stream in Sonoran Desert. (Photo: Apache-Sitgreaves National Forests)

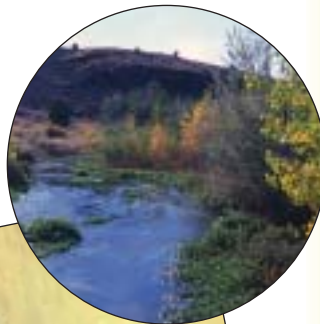
Stream in Cochiti Pueblo, New Mexico, revegetated with cottonwood poles. (Photo: David Dreesen)

Other methods of reintroducing trees and shrubs have proved successful on degraded riparian areas that presently do not experience flooding. Planting long-dormant stem cuttings, known as poles, from cottonwood, willow, and other riparian species into augered holes that extend to the water table has allowed the re-establishment of riparian trees on hundreds of acres in the Middle Rio Grande Valley (Dreesen and others, 2002). Containerized plants with very deep root systems have helped establish additional species not suited to pole planting in areas with a fairly shallow water table. These methods are stopgap because the plants will not regenerate unless flooding is eventually reintroduced into the riparian system.
