Maximizing Infiltration Efficiency at Leaky Acres

Dennis E. Peyton, P.E. – Sediment Solutions

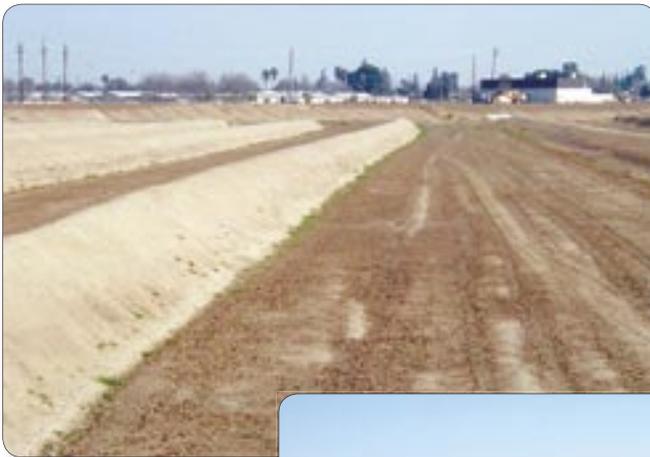
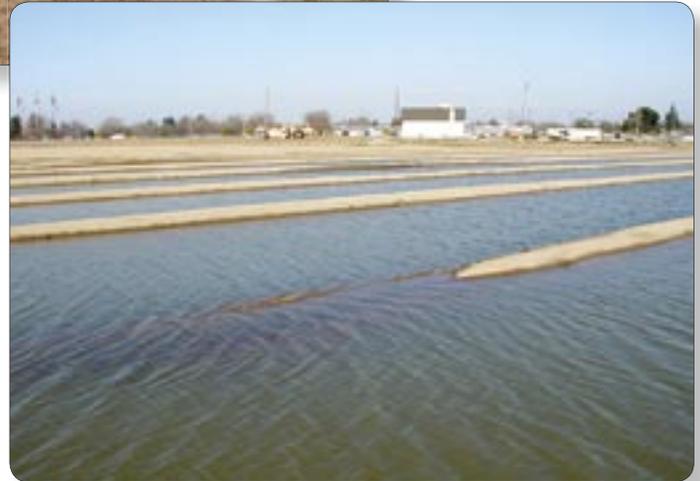
(left) Construction of a recharge basin using the ridge and furrow design. (below) Partially filled basins showing the ridgetops exposed for wave action. Photos by Dennis E. Peyton.

Sediment Solutions developed a basin design that keeps portions of the infiltration basin relatively free from sediment accumulation. It has been employed at Leaky Acres and more than 30 other recharge and treated wastewater disposal basins. The design is based on a recognition that sediments tend to settle and migrate to the lowest elevation available. Rather than creating a flat bottom, large, parallel ridges are constructed in the basin bottom. The ridges provide side slope areas that remain relatively sediment-free and therefore permeable. Wide, flat furrows between the ridges collect the sediment and become clogged. Continued permeability of the ridge areas more than compensates for the clogging in the furrow areas.

In most applications, the submerged ridges sustain their permeability with only periodic dewatering for maintenance. Operating the water level just above the top of the ridges takes advantage of surface wave energy to minimize the accumulation of fines on the upper areas of the ridges. Over time, however, inorganic and organic loading may impact the permeability of the submerged ridges; how quickly this occurs depends on the quality of the source water and other environmental conditions.

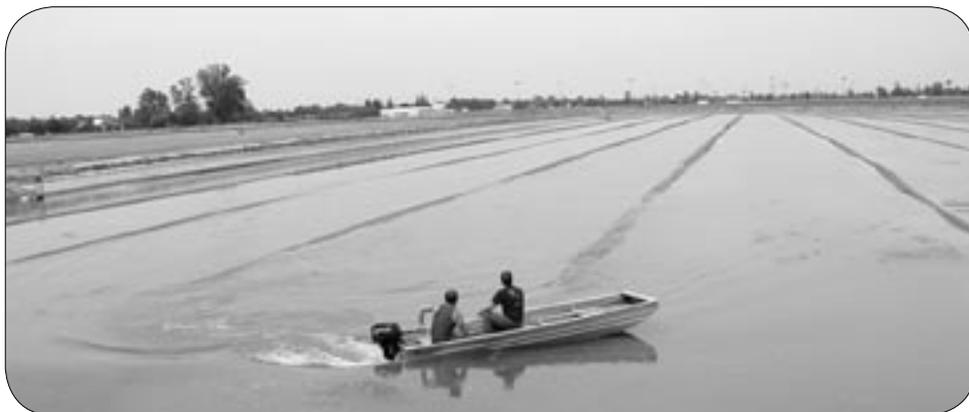
Wave washing by boat to clean ridges. Photo by Dennis E. Peyton.

of the submerged ridges and descends along the side slope, wind-induced waves re-suspend many or all of the accumulated sediments, which migrate toward and ultimately into the furrow area, as the water level continues to descend toward the furrow. This method does not require emptying the basin, drying it, or use of heavy equipment that can compact the underlying sediments: a significant improvement over previous methods. Drying just the ridge surfaces (with water standing in the clogged furrows) has also proven useful for desiccating algae deposits on the ridge surfaces and restoring ridge permeability.

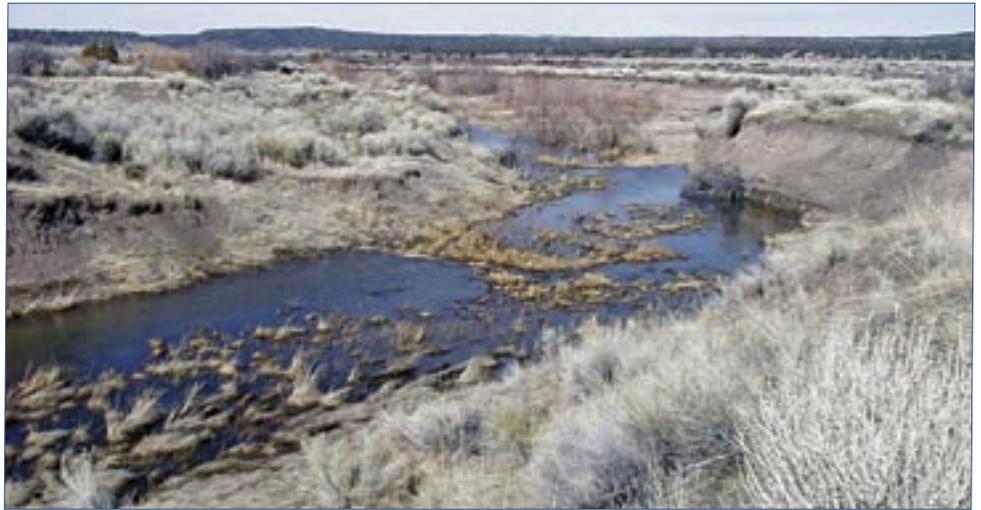
(above) Nutrioso Creek at EC Bar Ranch; (below left) planting willow seedlings; (below) installation of stream stabilization structures. Photos by Jim Crosswhite.

2. *Install stream grade stabilization structures to protect streambanks during high flow events and reduce water velocity.* Also with help from EQIP, more than 15 such structures were installed to raise the streambed and create a floodplain

4. *Revegetate the riparian corridor with grass and willows.* The seedlings and plantings were aided by sprinkler irrigation until they were established. Inefficient earth ditches, which lost 100 million gallons of water each year due to seepage and evaporation, were replaced with sprinkler irrigation systems supplemented with pipe,

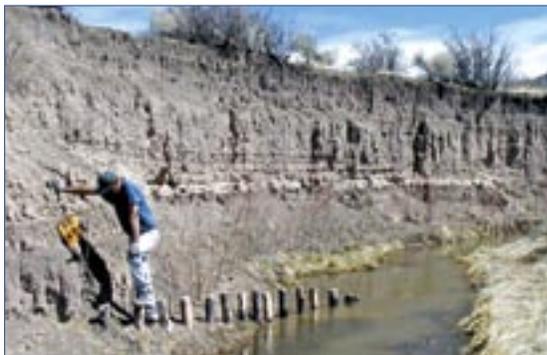
in deeply gullied channel reaches.
